TREE INSPECTION: A CONTINUOUS PROCESS

By Steve Connally, CTSP

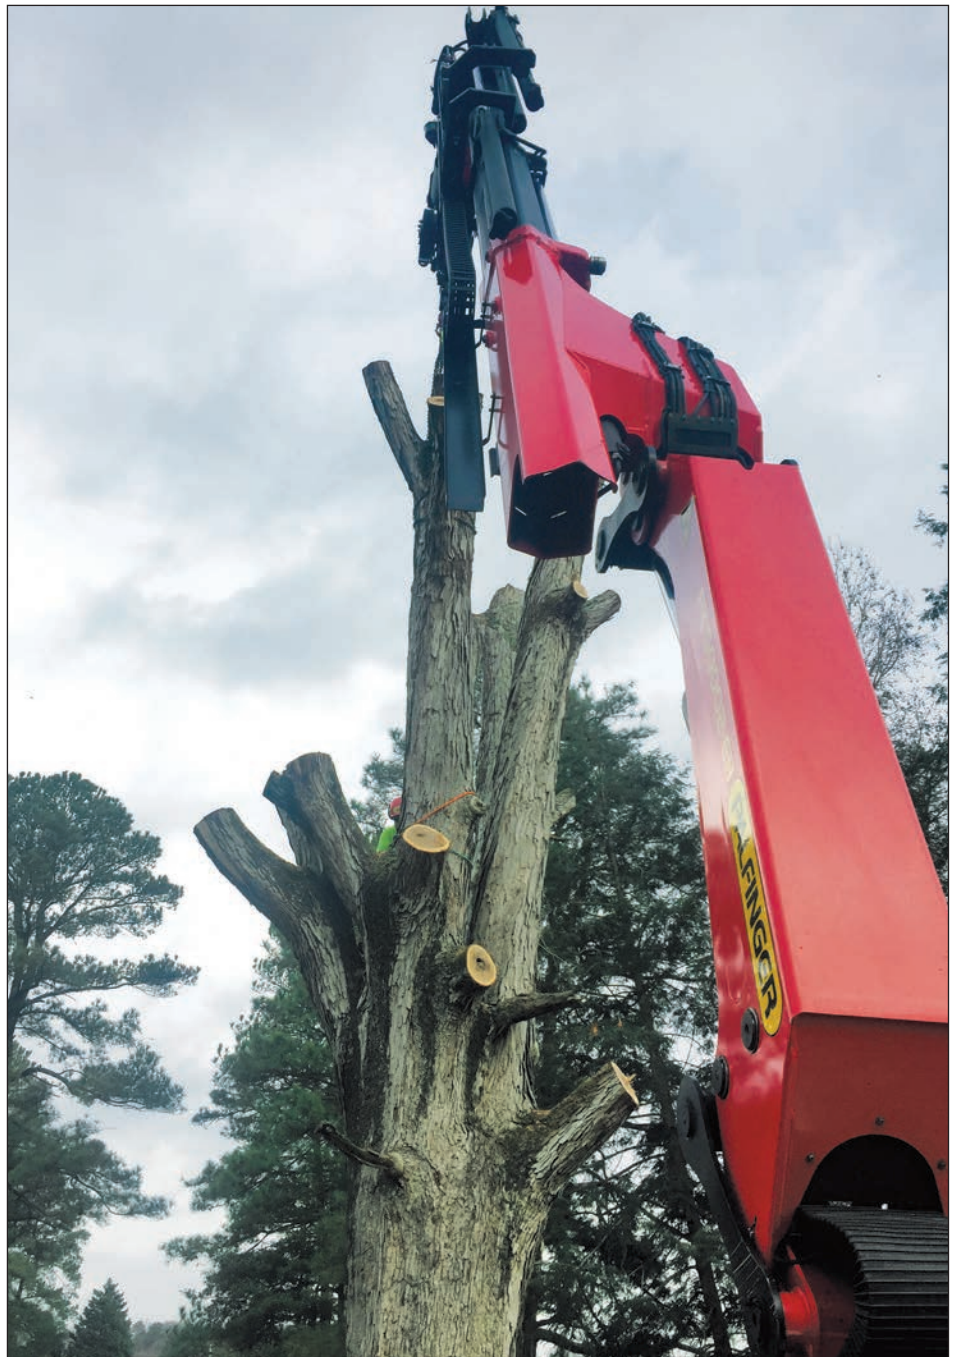
Photo 1: Day 1 involved limbing out the white oak with the grapple saw until we had manageable pieces to pick. Day 2, shown here, involved picking the trunk in manageable pieces and cleaning up. All photos courtesy of the author.

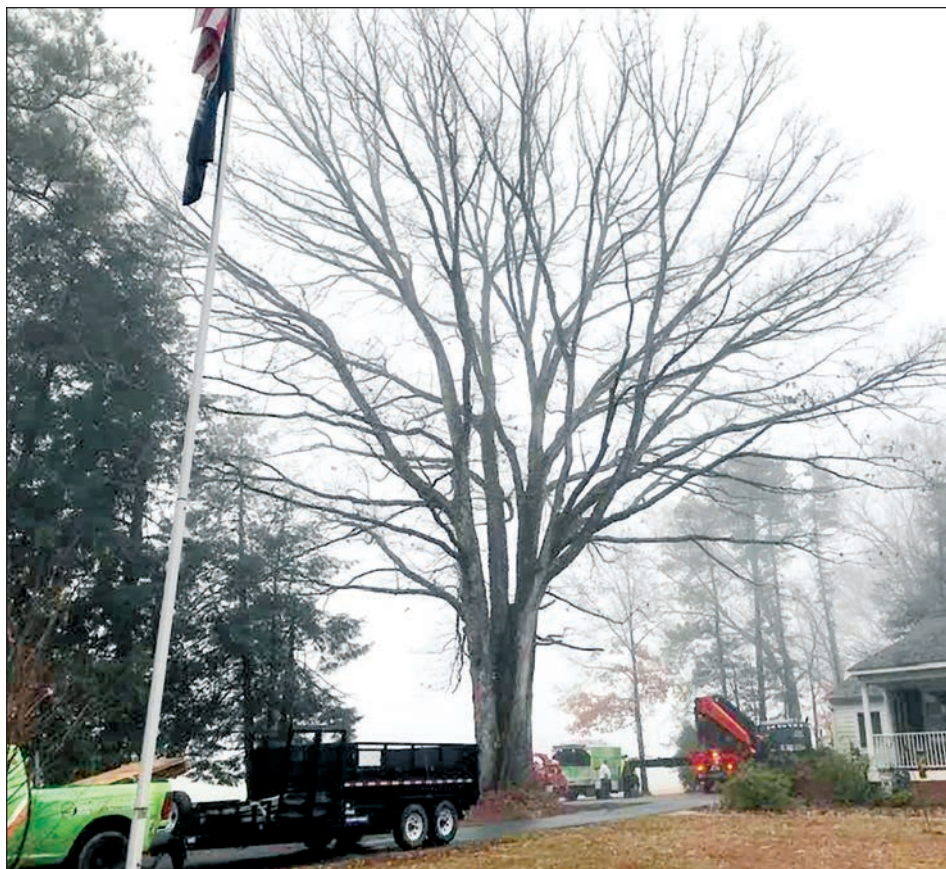
Photo 2: The job involved removing this massive white oak, *Quercus alba*.

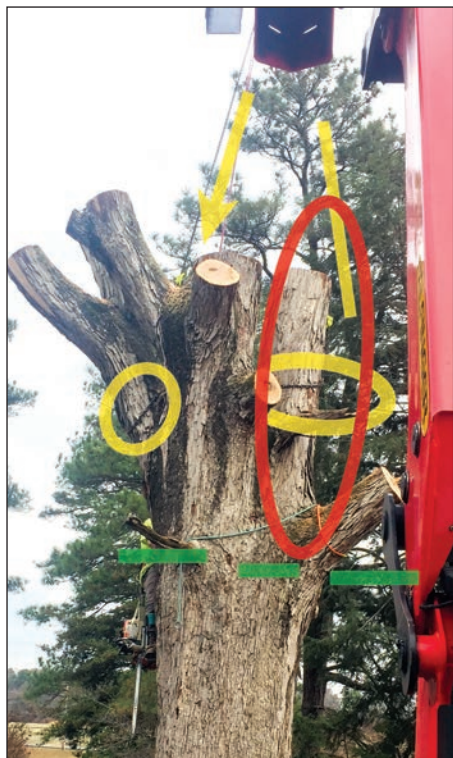
In **Photo 3**, the yellow highlights indicate the lifting bridle. The green highlights show the location of the cut. From my vantage point on the ground, it appeared to be low enough into trunk wood to prevent any separation of the leads coming together on the base of the cut. (**Photos 3, 4 & 5**)

Photo 3: The yellow highlights are the lifting bridle. The green highlights show the location of the cut.

An assessment of the rigging and the material on the ground revealed a significant amount of included bark not visible from the base of the tree. The sling angle of the rigging, although less than 120 degrees, contributed enough force inward to cause the pieces to separate, resulting in the near-catastrophic event. (Photos 6 & 7???) The final pick weight was 7,100 pounds. The lead circled in red was the section that separated from the main trunk wood. (Photo 3)

A thorough evaluation and assessment, after the fact, showed how we could have more successfully managed this material. In retrospect, I would have called for each of the smaller leads to be picked individually. My initial concern was that taking those leads off would result in an unbalanced piece without enough butt weight. This proved to be the lesser of all evils.

A second plan would have been to place load binders above the cut. Unfortunately, there were none on site. Believe me when I tell you I ordered some immediately after this incident and now carry them on my rig.

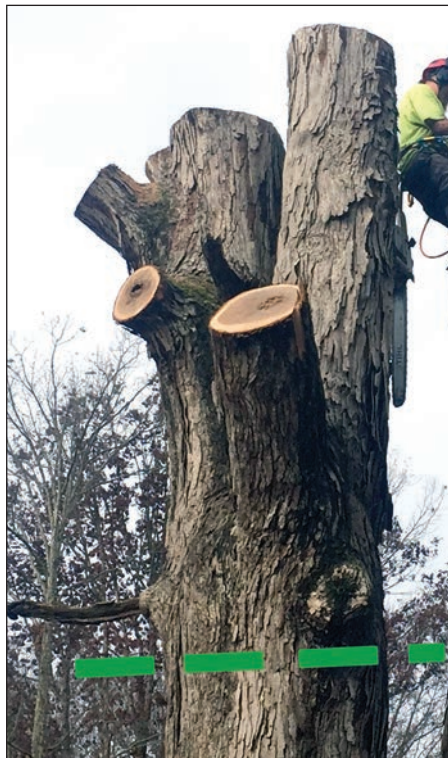
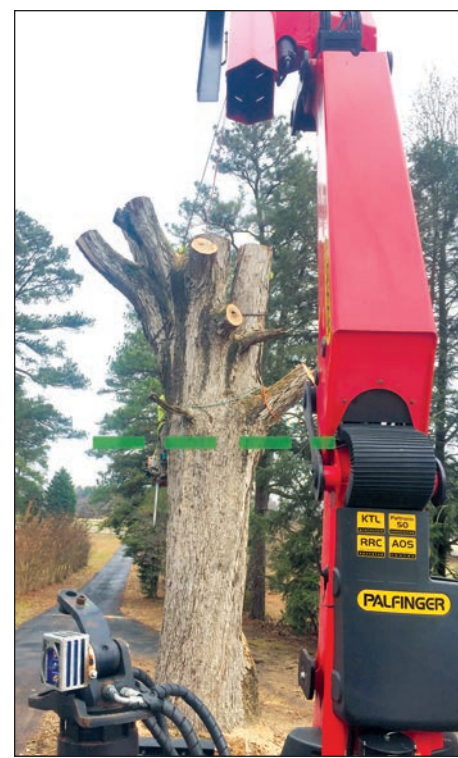
Photo 4 & 5: From my vantage point on the ground, the location of the cut appeared to be low enough into trunk wood to prevent any separation of the leads coming together on the base of the cut.

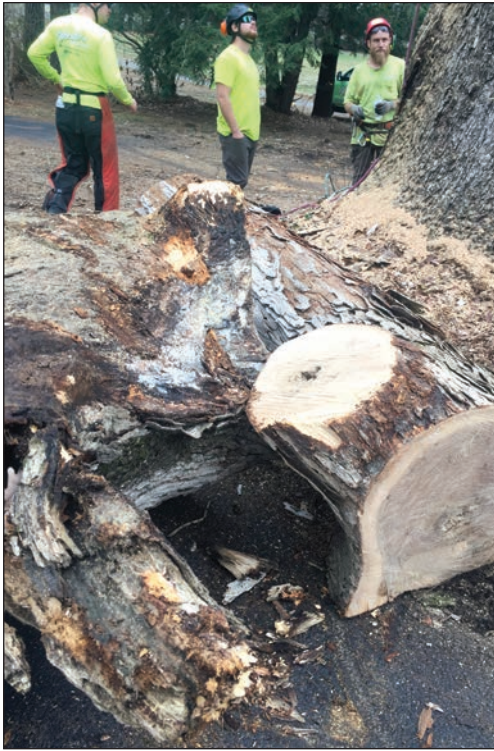
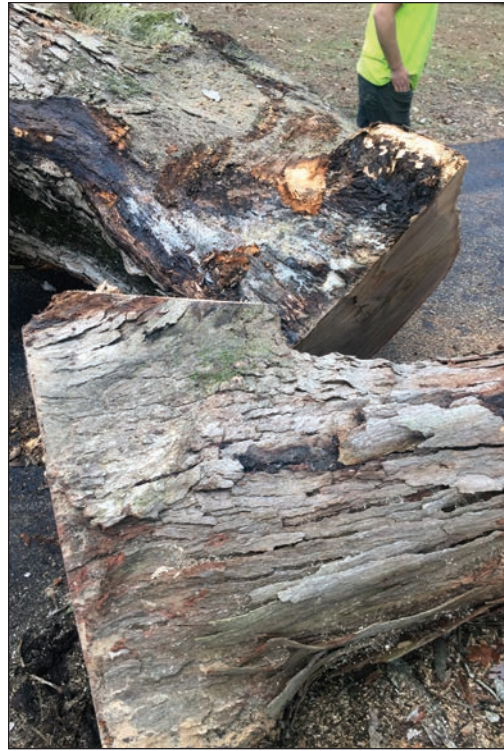
Photos 6 & 7: An assessment of the rigging and the material on the ground revealed a significant amount of included bark not visible from the base of the tree.
